REPORT OF INVESTIGATION

**Fatal Powered Haulage Accident
June 20, 2003**

**Beechfork Mine
Bledsoe Coal Corporation
Helton, Leslie County, Kentucky
ID No. 15-18376**

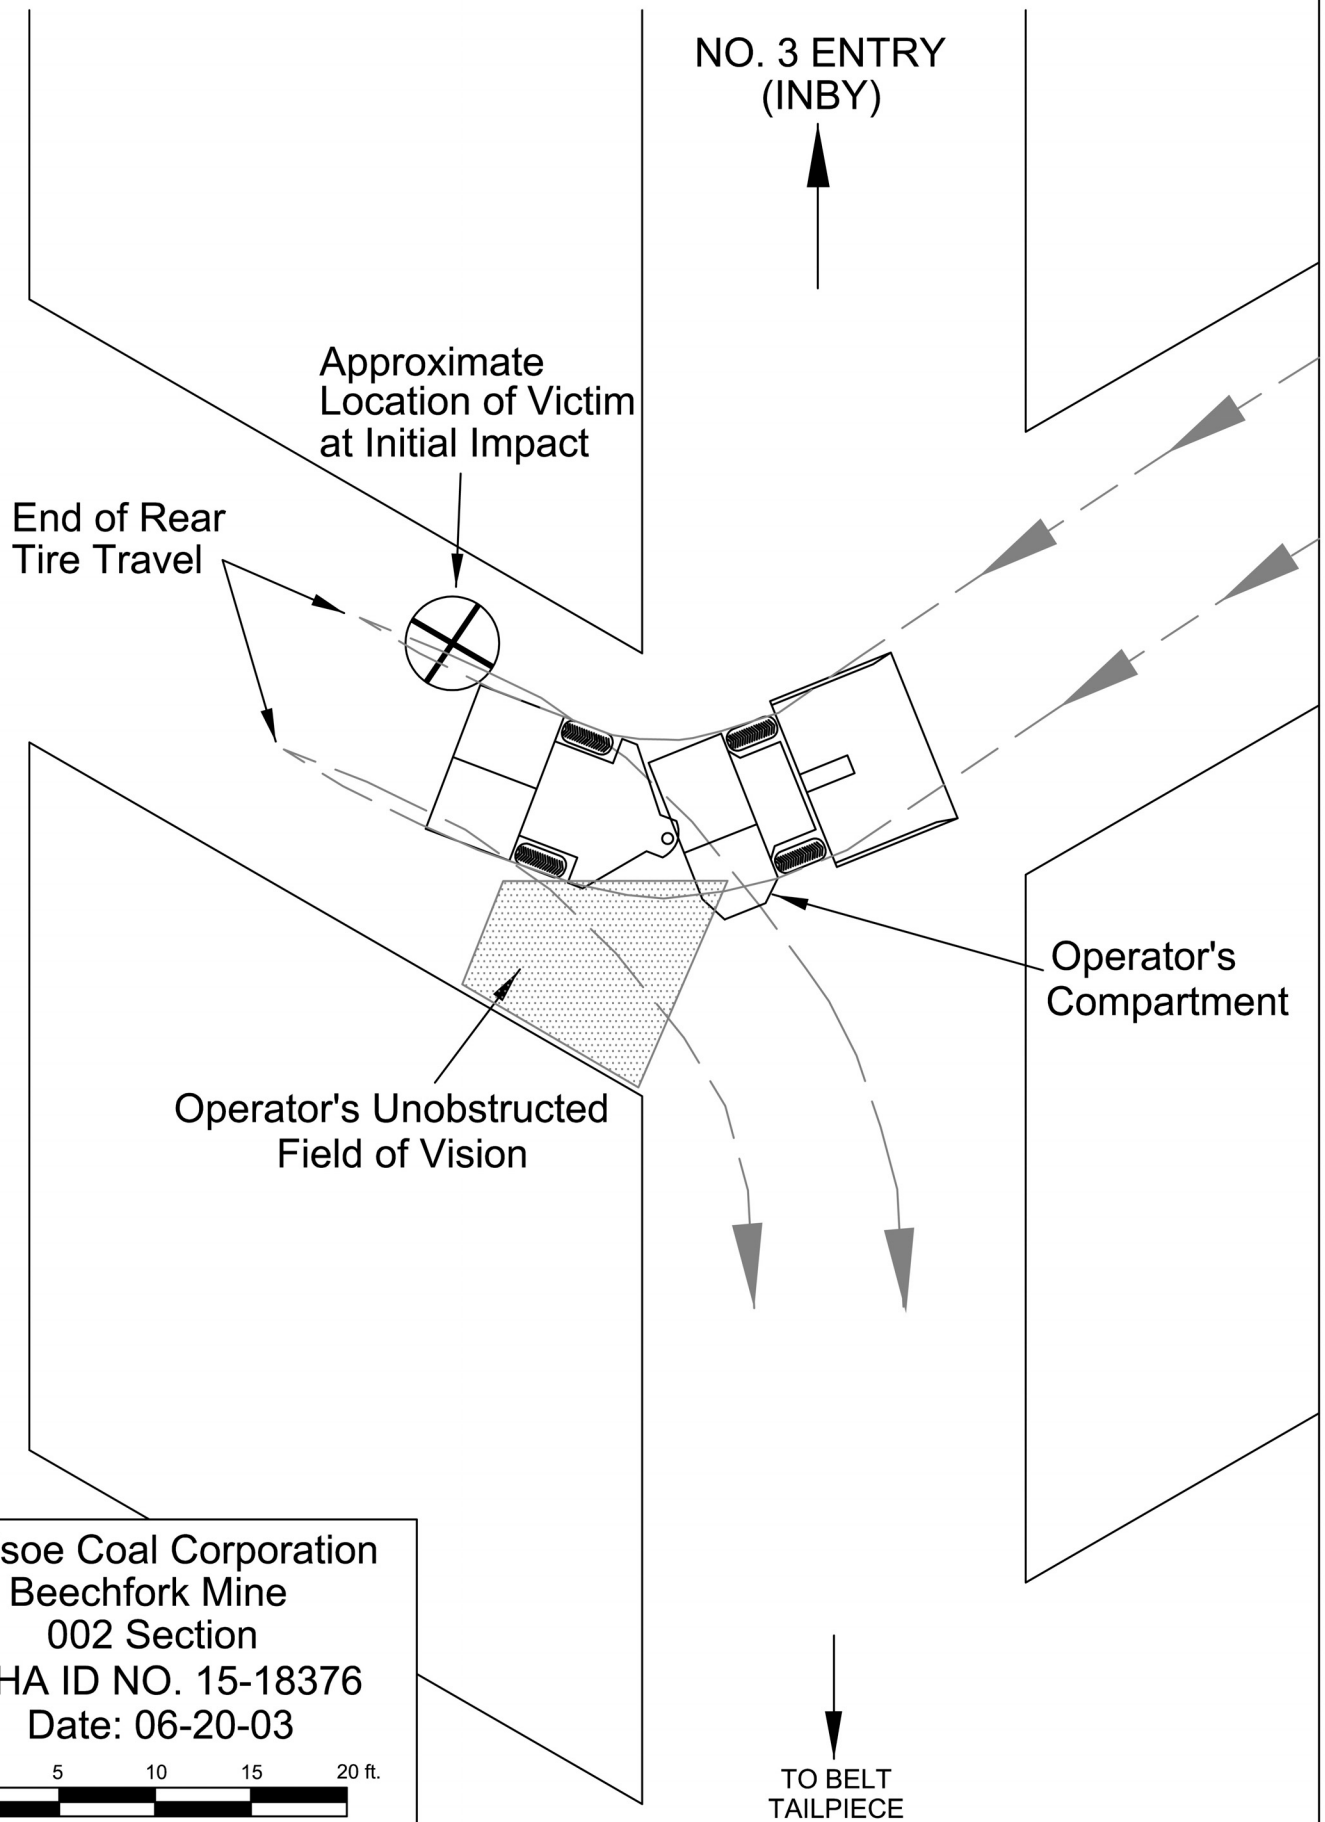
Location of Scoop and Victim at Time of Accident

Crosscuts on the 002 MMU, including crosscut 29, were turned at 60-degree angles, left and right out of the belt entry. Also, centerlines for crosscuts to the right of the belt were offset ten feet in by those to the left of the belt entry. The scoop had to make an acute right turn as it crossed the No. 3 entry and into the accident site. This would have obscured the scoop

operator's vision along the inby side of the crosscut as the battery-end of the scoop, located on a separate articulated section from the operator's compartment, entered the crosscut.

The scoop was equipped with a canopy for the operator's compartment. The scoop operator stated his field of vision while traveling battery-first was directed along his side of the machine toward battery end and he could see the outby corner of the crosscut. (See sketch) In this mining height when a scoop operator is positioned in the operators' deck, his normal body posture would be in a reclining position and his field of vision would be directed along the operator's side of the machine. If the mining height would allow the operator to view over the top of the machine, it was through a 10½-inch opening between the canopy and the top of the scoop frame. However, the top of the scoop batteries were 7½ inches higher than the top of the scoop frame. This was caused by 7½-inch wide metal flanges on both sides of the battery tray that held the Exide E110W-21 (1100 A.H.) Batteries, preventing the battery tray from being completely seated down into the frame of the scoop.
